Evaluation of the Condition and Prediction of the Remaining Life of the Old Kutai Bridge Using the Bridge Management System (BMS)

Sigit Herananda Prabowo*, Tukimun, & Wahyu Mahendra Trias Admaja

Abstract: The Kutai Lama Bridge, which has been in operation for 15 years in Kutai Kartanegara Regency, East Kalimantan Province, is a critical infrastructure experiencing deterioration, with signs of damage in the expansion joints and corrosion on the steel structure. Evaluation using the Bridge Management System (BMS) indicates that the bridge is in severely damaged condition, with a Condition Index (NK) of 3. The remaining life of this bridge is 8.722 years. Based on these findings, this study recommends a rehabilitation program to ensure the bridge's operational sustainability, with an estimated budget of IDR 7,879,754,000.00.

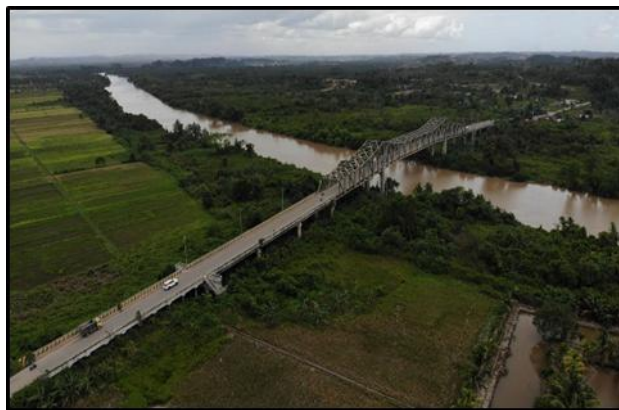
Figure 2. Aerial photo of the old Kutai bridge

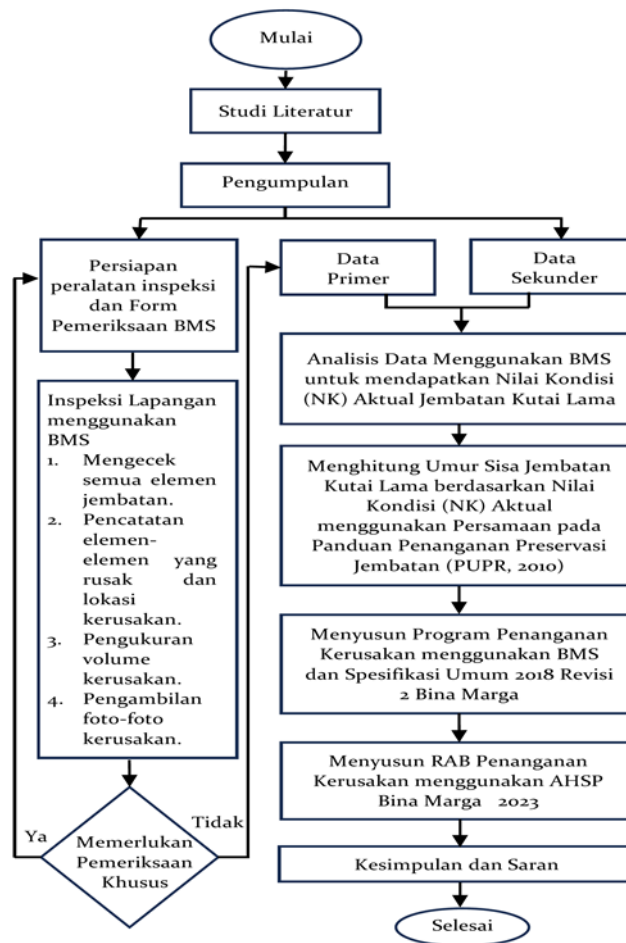
Figure 3. Research flow chart

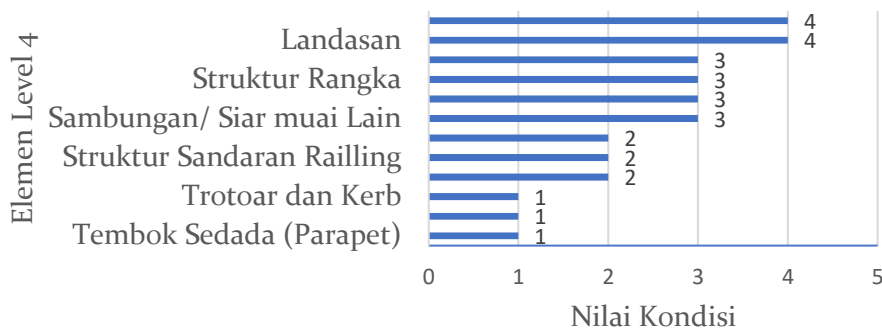
Priority for handling identified damage is based on the lowest condition value (NK) which can be seen in Figure 5.

Figure 5. Order of Element Condition Values from lowest condition

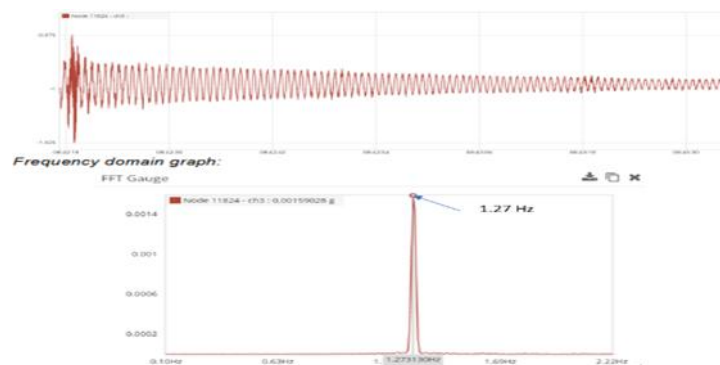
Figure 7. Impulse vertical mode frequency 1

The vertical mode dynamic test results, impulse 1 is 1.27 Hz, impulse 2 is 1.27 Hz, impulse 3 is 1.27 Hz, the results are consistent at a value of 1.27 Hz. The actual natural frequency is relatively higher compared to the empirical frequency, namely 0.95 Hz. This shows that the existing bridge structure is stiffer than the empirical theoretical limits. The natural frequency difference of 0.32 Hz shows that the bridge structural capacity is in good condition.

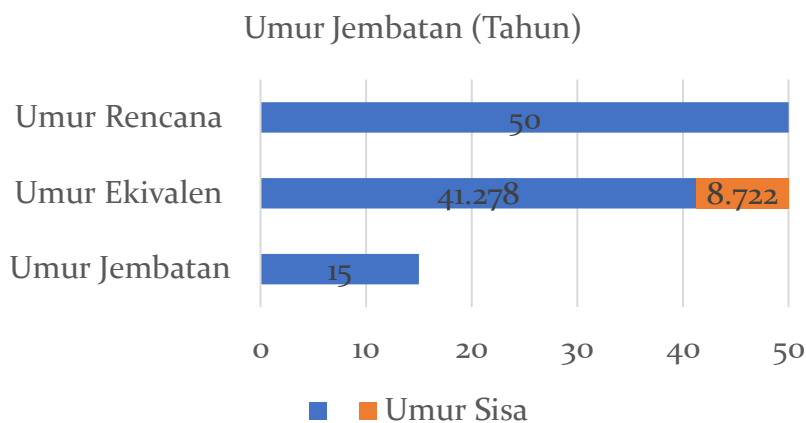
Based on the calculations above, the current equivalent age of the bridge is estimated to be 41,278 years. The remaining life of a bridge with a condition value of 3 is 50 years – 41,278 years = 8,722 years.

Figure 8. Comparison of the age of the old kutai bridge
